# PUBLIC ROADS

VOL. 15, NO. 6 ▽ AUGUST 1934

A Study of Oil-Treated Roads in Colorado and Wyoming . . . . . 137

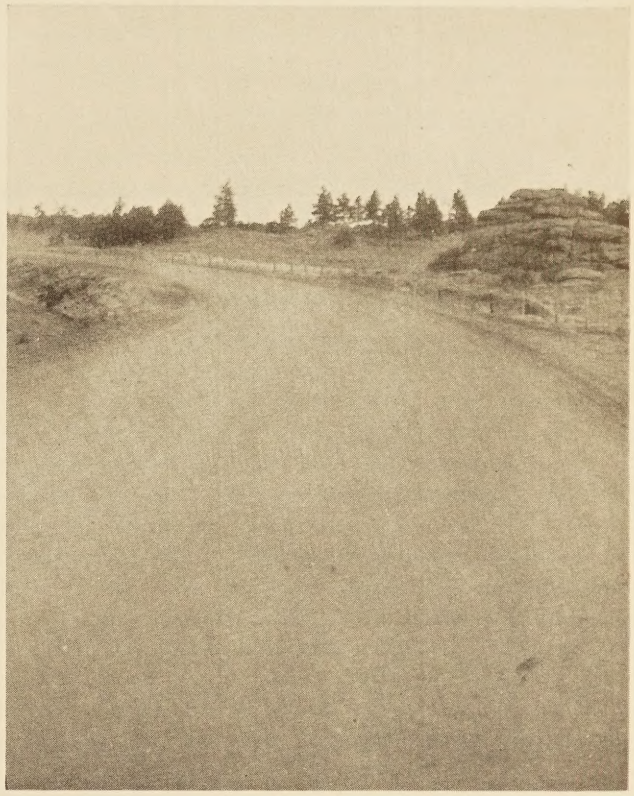
A Smooth Riding Surface Between Fort Collins and Laramie Typical of Most of the Surfaces Inspected.

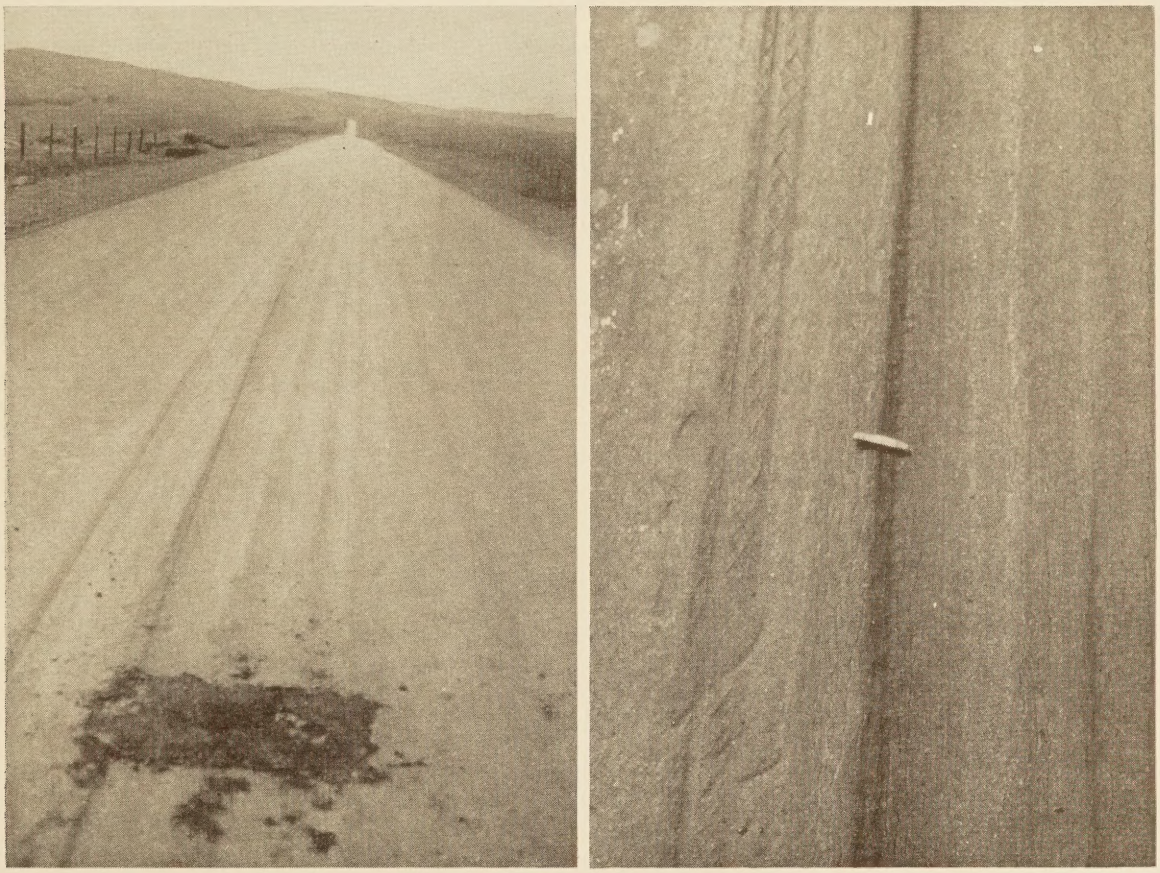
General View and Detail of a Surface of Group 1 Which Was Highly Unstable Due to a High Combined Oil and Water Content. Age Approximately One Year at Time of Inspection. Note Tire Marks and Foot Tracks on This Surface.

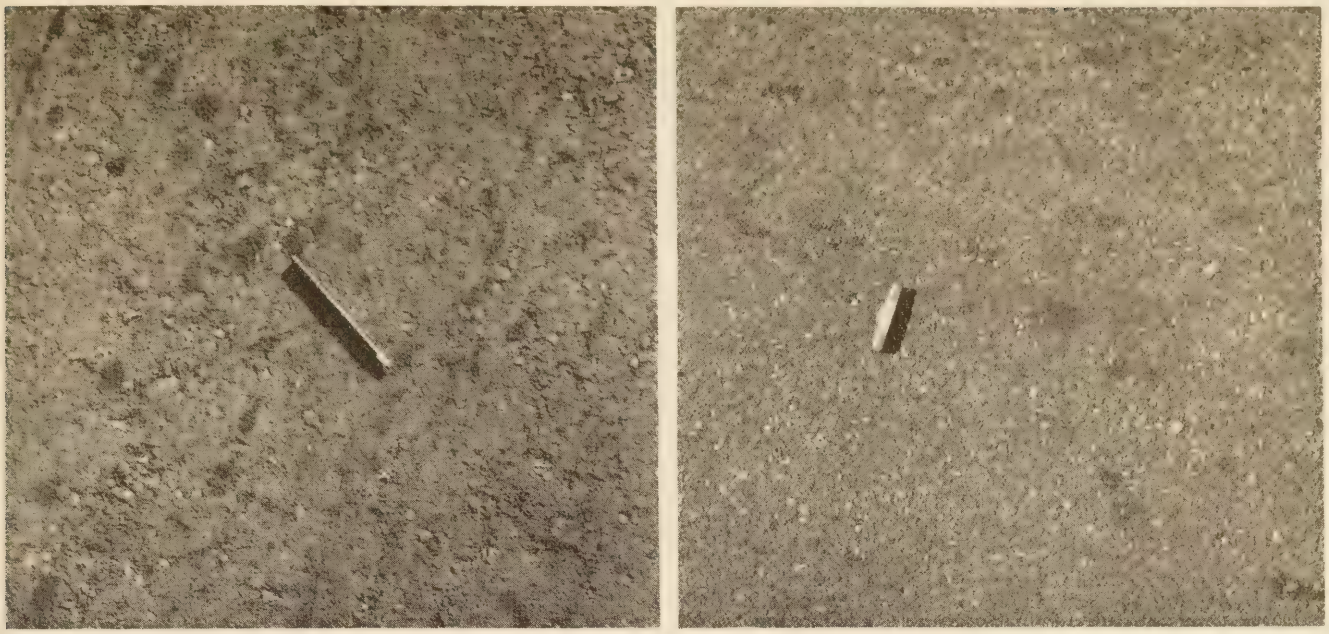
Typical Oil-Mix Surfaces Which Have Given Excellent Service. The Mix Shown on the Left Was Rich and Unstable the First Year and Was Remixed with Additional Gravel. It Was Three Years Old at the Time of Inspection. The One on the Right Had Received No Maintenance of Any Kind Since Its Construction Four Years Prior to the Inspection.

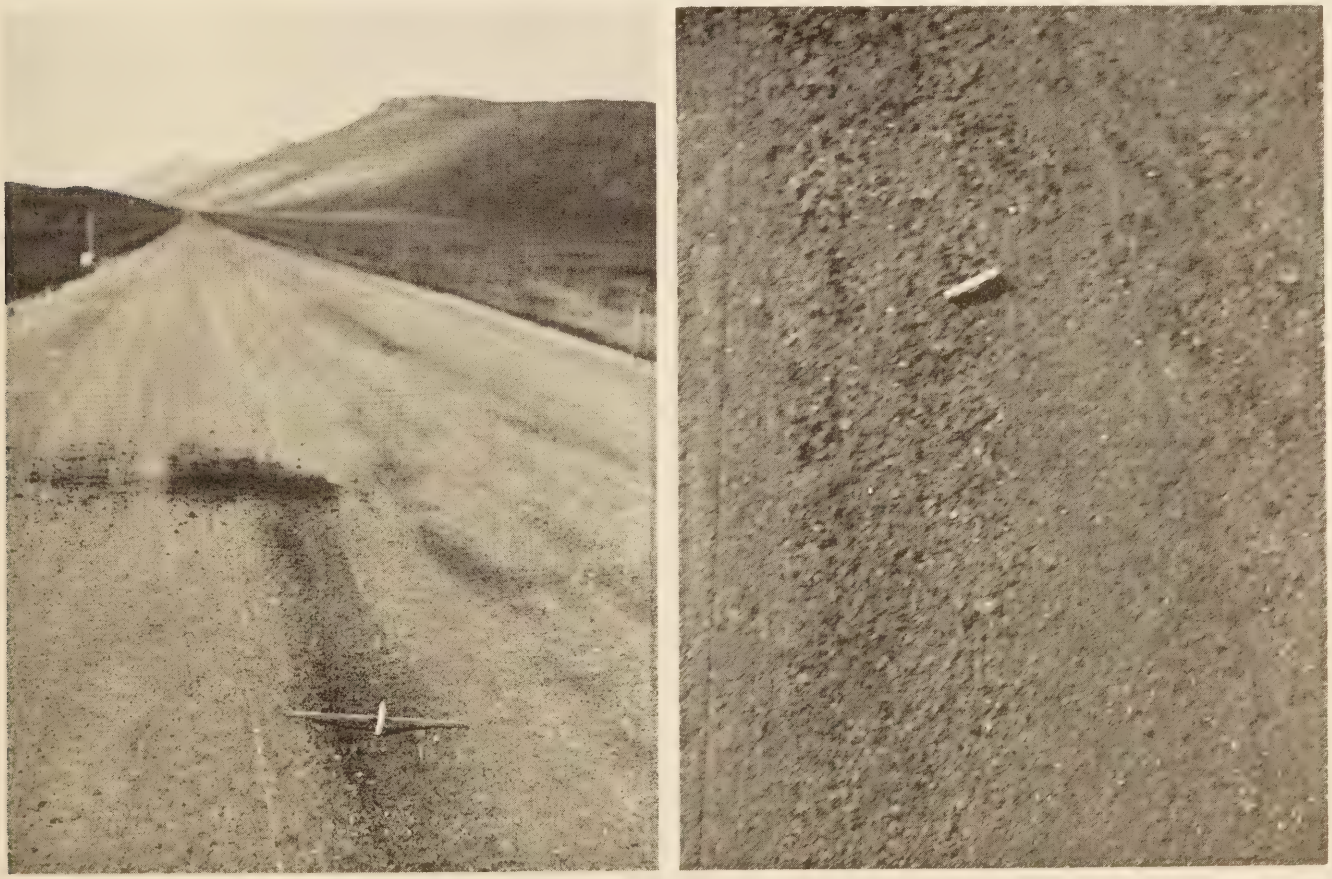
Typical Examples of Raveling of Group 3 Surfaces Having a Low Oil Content and No Seal Coat or Surface Treatment to Prevent Loss of Aggregate.

GROUP 3 SURFACE REPRESENTED BY SAMPLE 9. MIXTURE WAS LOW IN OIL CONTENT AND HAD BEEN SEALED TO PREVENT RAVELING. PICTURE SHOWS LOCAL AREA WHERE SEAL HAD PEELED AND RAVELING FOLLOWED. SEALED PORTION REPRESENTED BY SAMPLE 8 WAS IN EXCELLENT CONDITION.

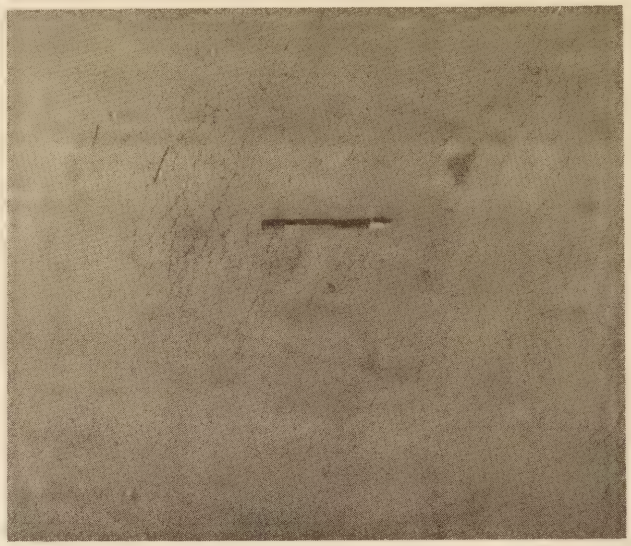
GROUP 1 SURFACE REPRESENTED BY SAMPLE 5. THE BASE WAS MOIST CLAY-GRAVEL. SURFACE SMOOTH AND FIRM BUT BADLY CRACKED.

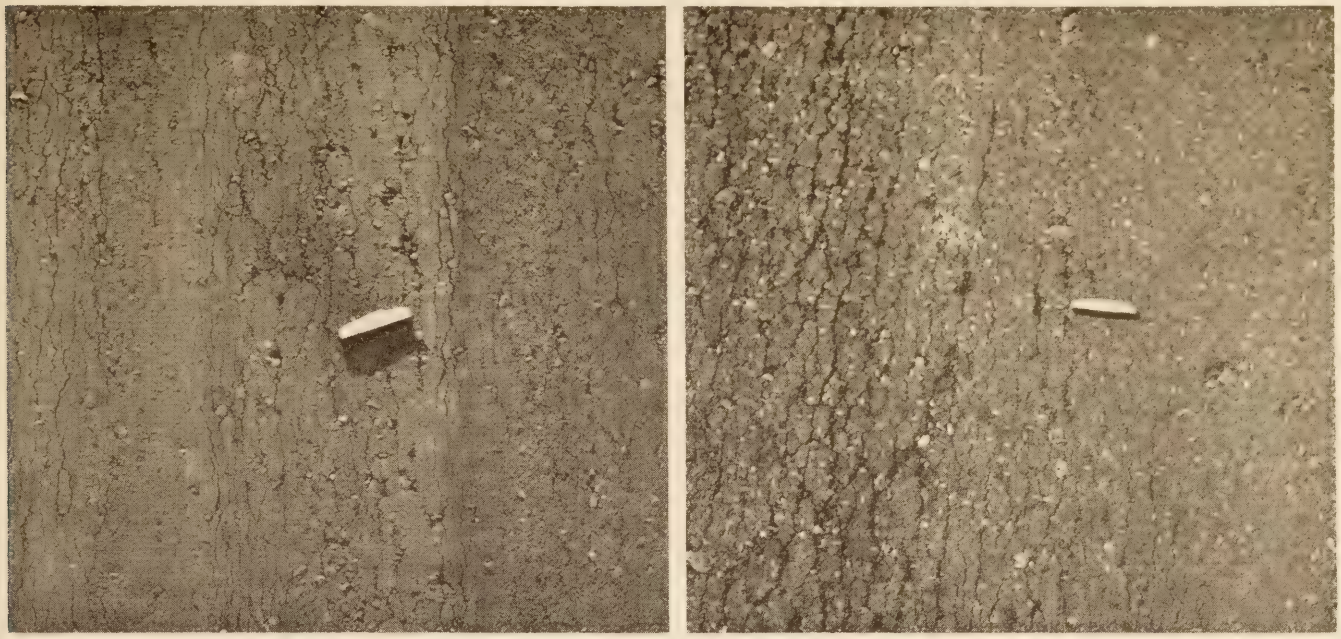
Typical Examples of Failure Caused by High Moisture Contents in the Mixtures. These Group 1 Surfaces Are Two and Three Years Old.

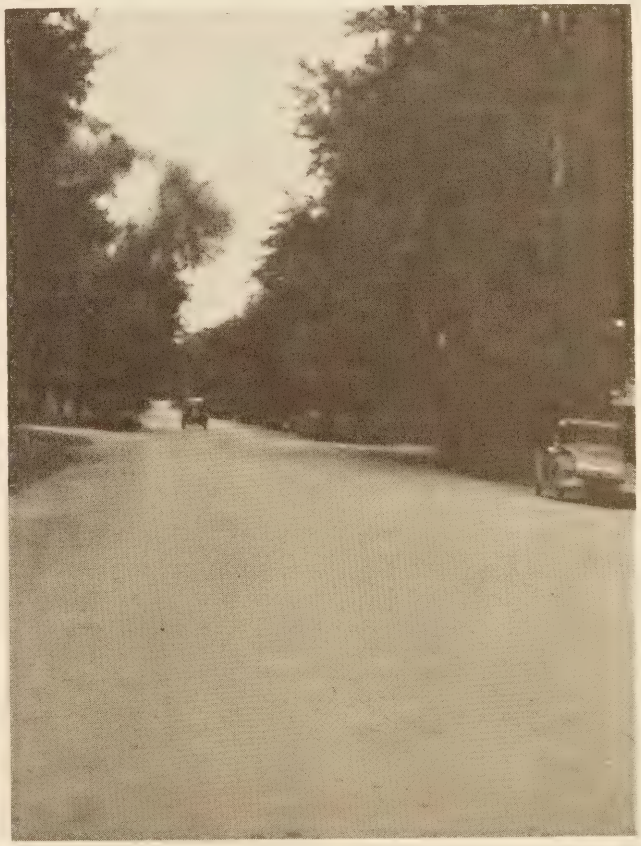
An Oil-Mix Surface in Boulder, Colo. Surface Has Carried Through Traffic for Three Years and Is in Excellent Condition Except for Occasional Small Cracked Areas.
